LIVESTOCK AND VEHICULAR UNDERPASSES SUPPLEMENT TO FINAL REPORT 98 CASE STUDIES

LIVESTOCK AND VEHICULAR UNDERPASSES

CASE STUDIES

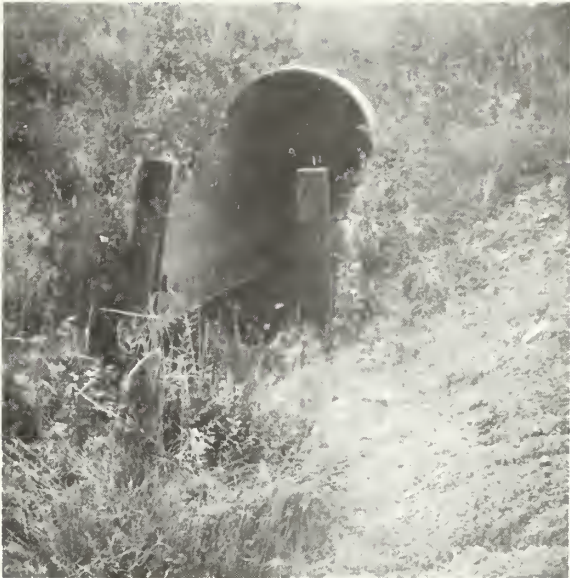
EAST ENTRANCE - Water in pipe

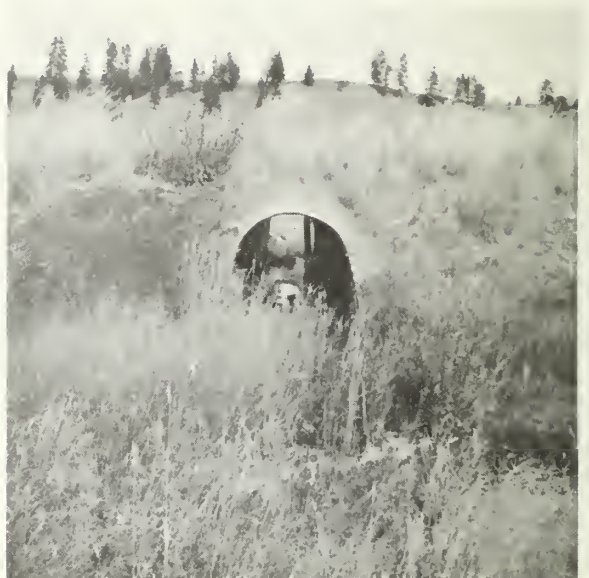
WEST ENTRANCE - Water in pipe

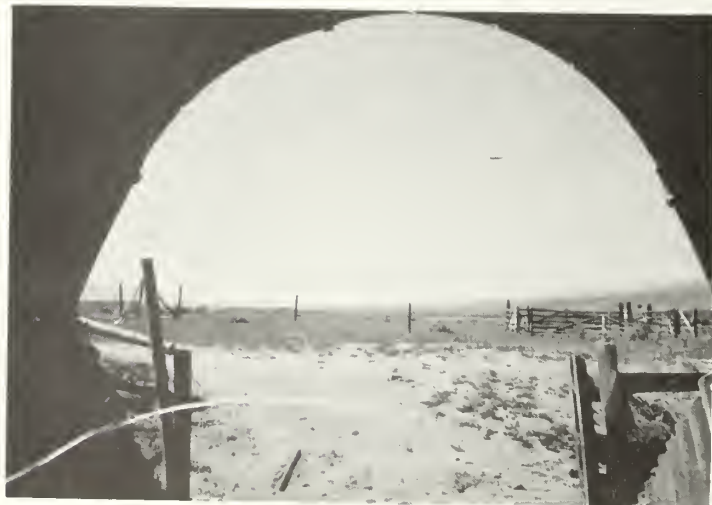
Looking South from Pipe; note fencing as compared to opposite entrance.

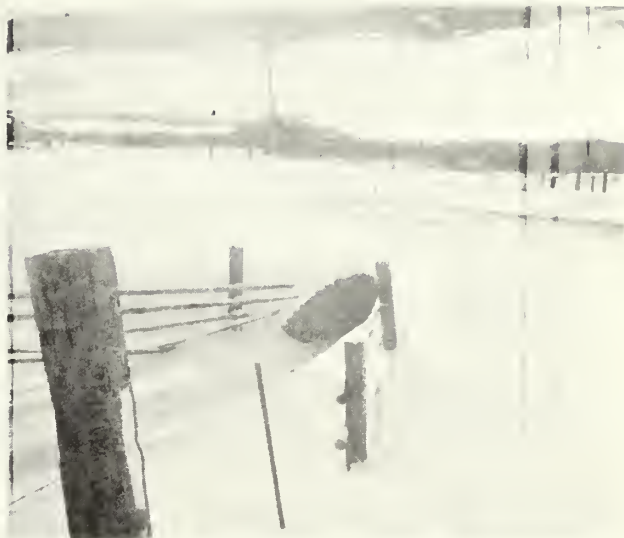
SOUTH ENTRANCE; Snow is about 2' deep, drifting to 6' adjacent to entrance.

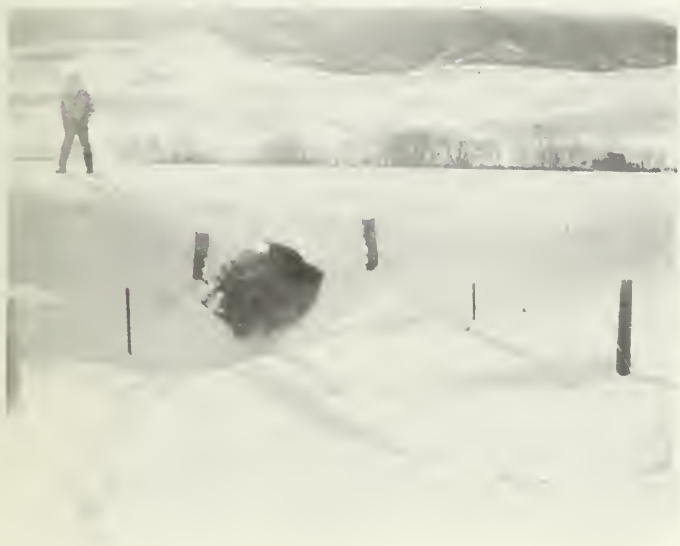
NORTH ENTRANCE; about 2' of snow
on level with drifting at entrance.

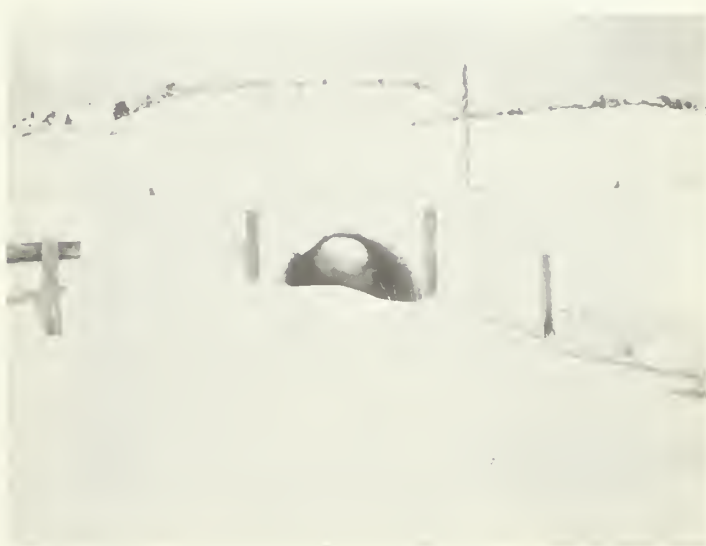
SOUTH ENTRANCE: drifting severe.

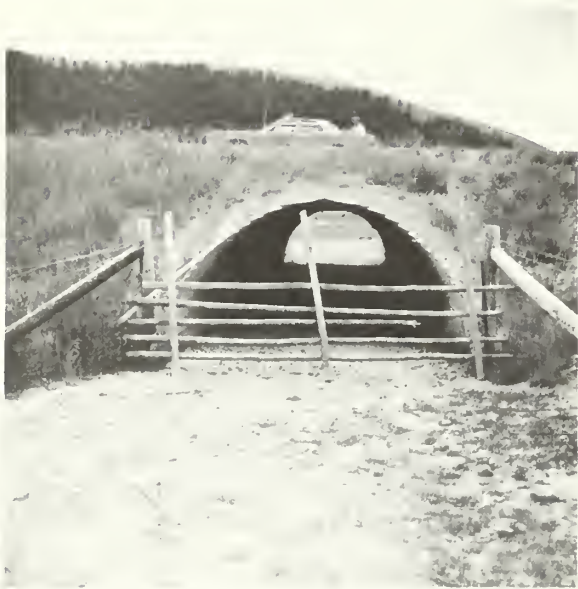
SPECIFIC PROBLEMS: Structure is much too small for large herd drives. Thirty individual ranchers belong to the Snowline Grazing Association and drive as many as 500 head at a time. It becomes a very boggy area during periods of runoff, and, although this provides bedding for the pipe, the soil does not contain enough gravel to keep a firm foundation.

ADEQUACY: Inadequate due to undersize and large volume of cattle usage. A larger arch pipe would have necessitated a raise in grade at that point. Stabilization of the pathway may have been possible with gravel or pavement.

EAST ENTRANCE; water and mud backs up beyond entrance.

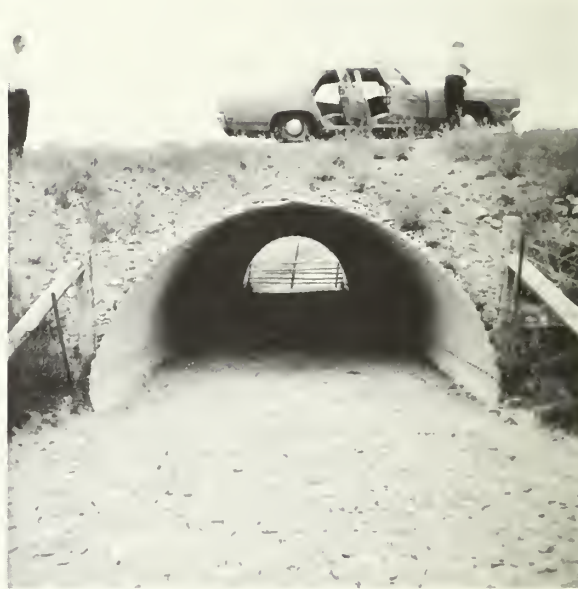
WEST ENTRANCE; water collects and area becomes a quagmire of mud. Very poor drainage.

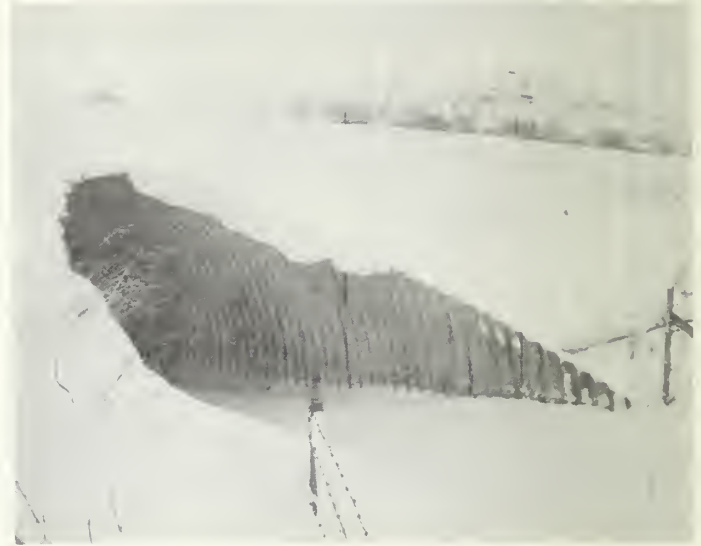
SOUTH ENTRANCE; very little drifting;
about 2' of snow near entrance.

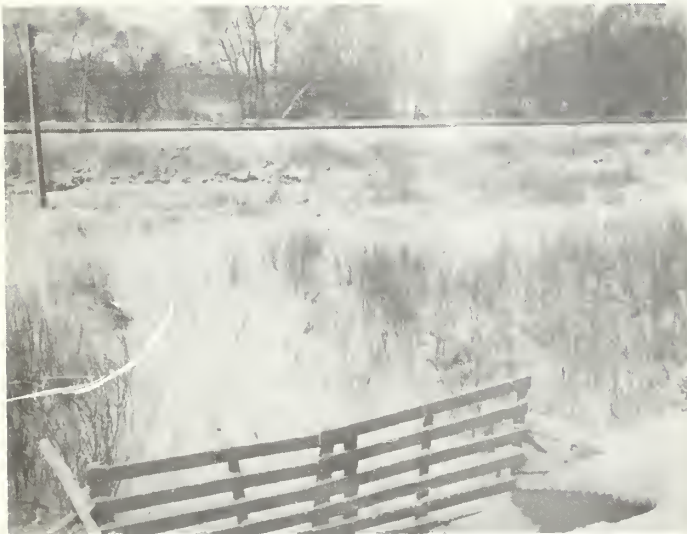
Looking North from NORTH ENTRANCE; almost
1' of snow on level between stockpass
and railroad.

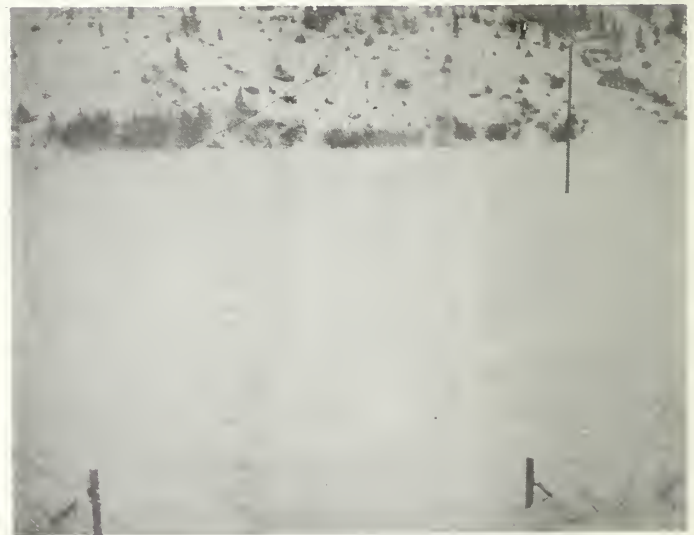
Looking South from SOUTH ENTRANCE;
little drifting, about 2' of snow on
level.

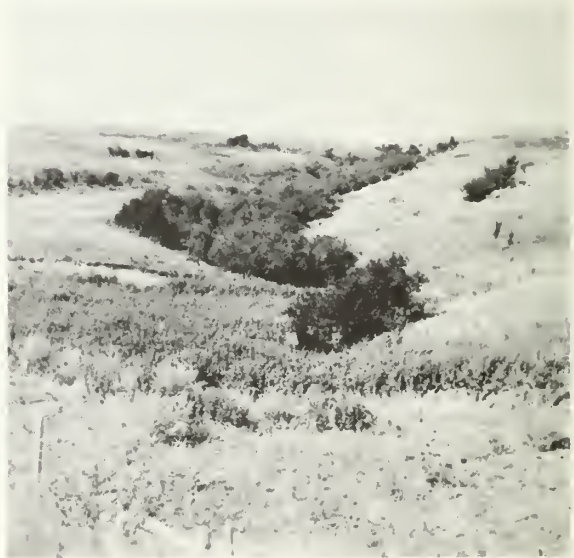
LOOKING WEST
Notice drainage draw

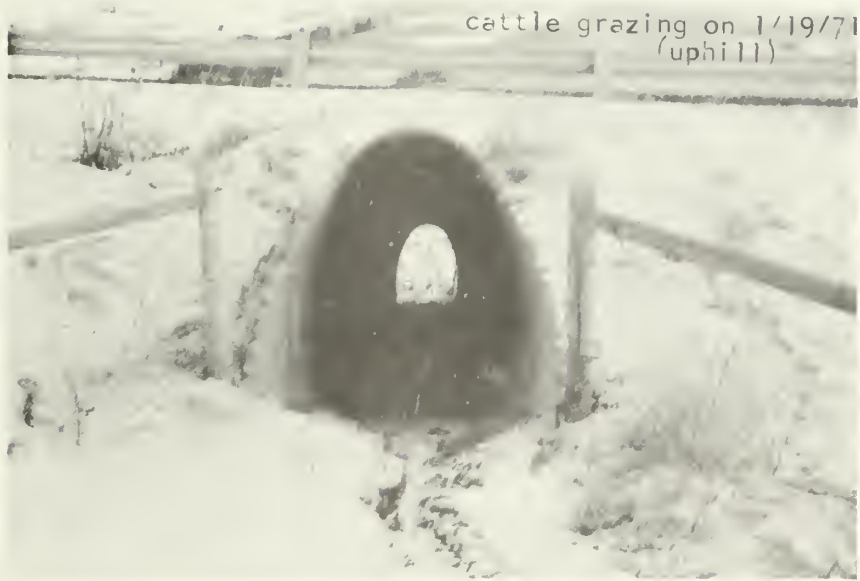
EAST ENTRANCE
Notice drainage from upper draw

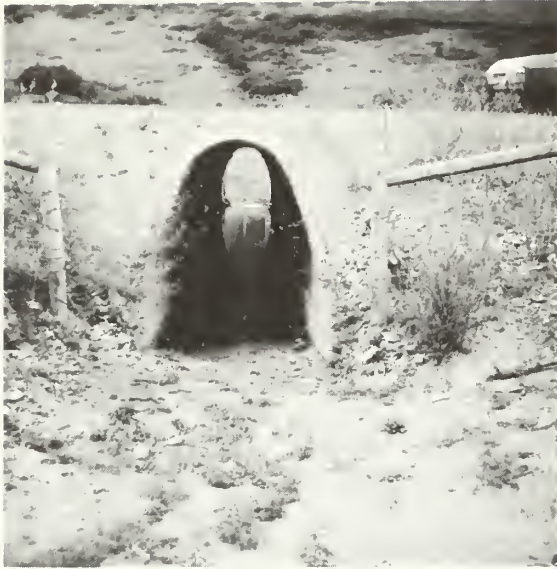
EAST ENTRANCE; 6" of water

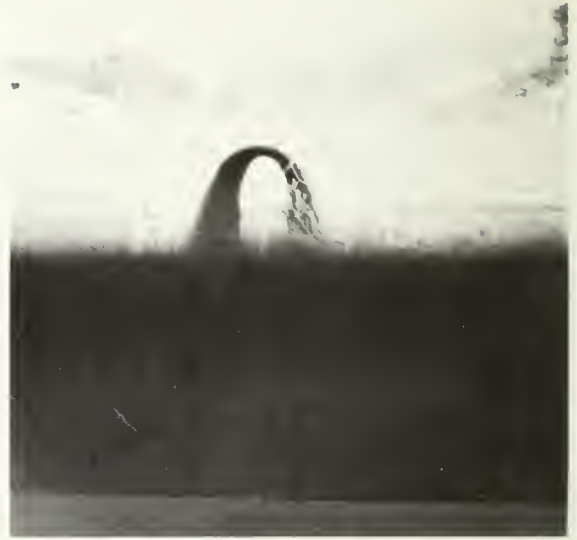
WEST ENTRANCE; 6" of water

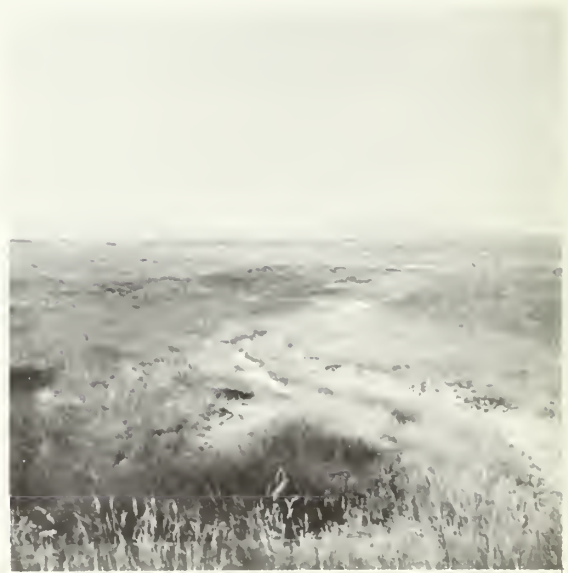
REMARKS: Access stabilization appears to be a problem for the combination drainage-stockpass structure. Possibly some combination of rock and asphaltic pavement is a necessary combination for these structures. The unusual runoff was not normal for the year, and the water ran over the highway, so the design was probably adequate to handle drainage for the normal years. This affects stock movement during the rainy months.

LOOKING WEST; Notice drainage area

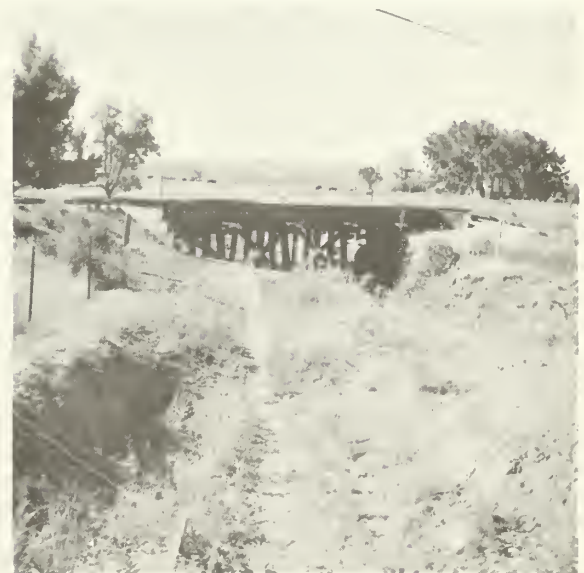
Looking southeasterly from SOUTHEAST
ENTRANCE, showing trail under rail-
road bridge

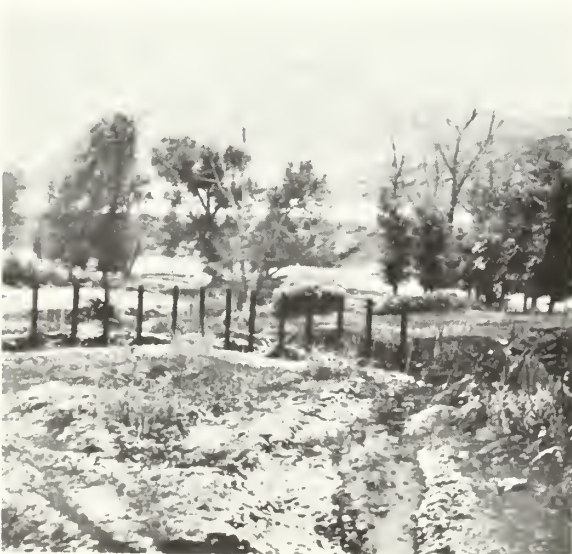
Looking North from NORTH ENTRANCE
Notice "I" beams for high water debris

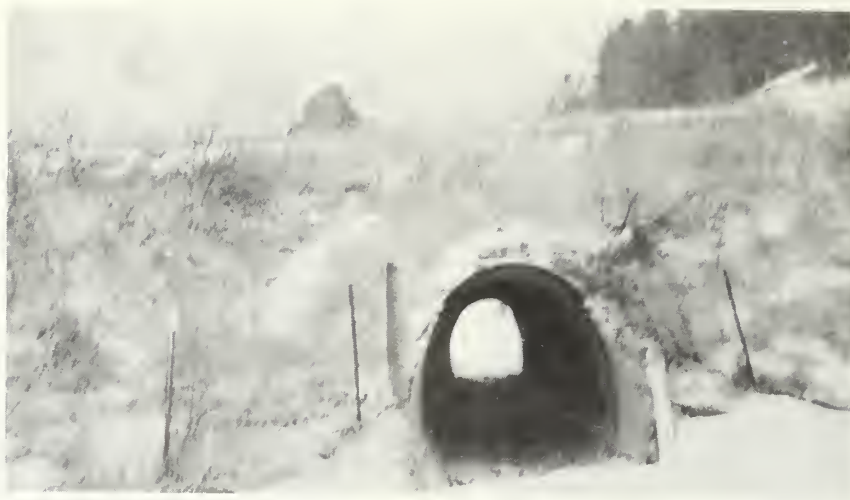
Cow is supposed to have died in this stockpass,
according to landowner. (slipped on the ice)
Confirmed existence of carcass in stockpass.

WEST ENTRANCE

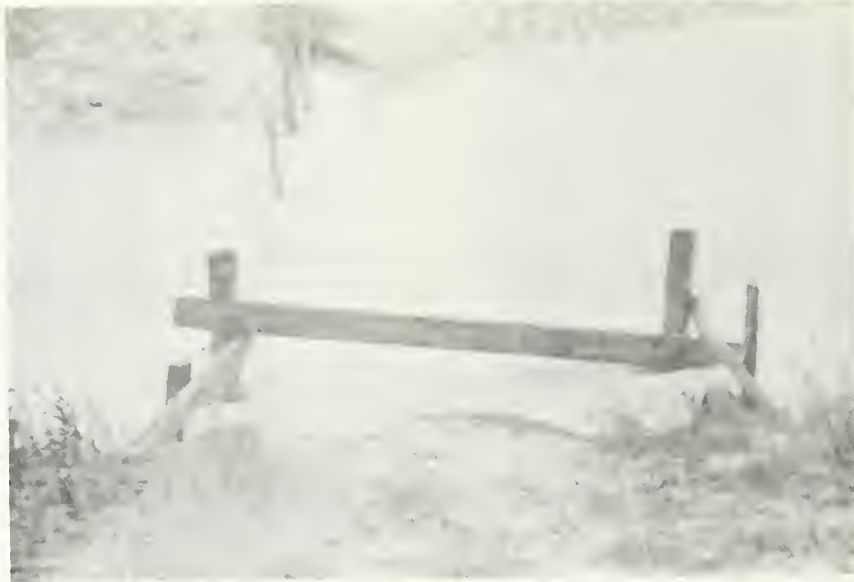
Looking EAST from EAST ENTRANCE
Notice drifting pattern, refer
to photo in same location on
previous page.

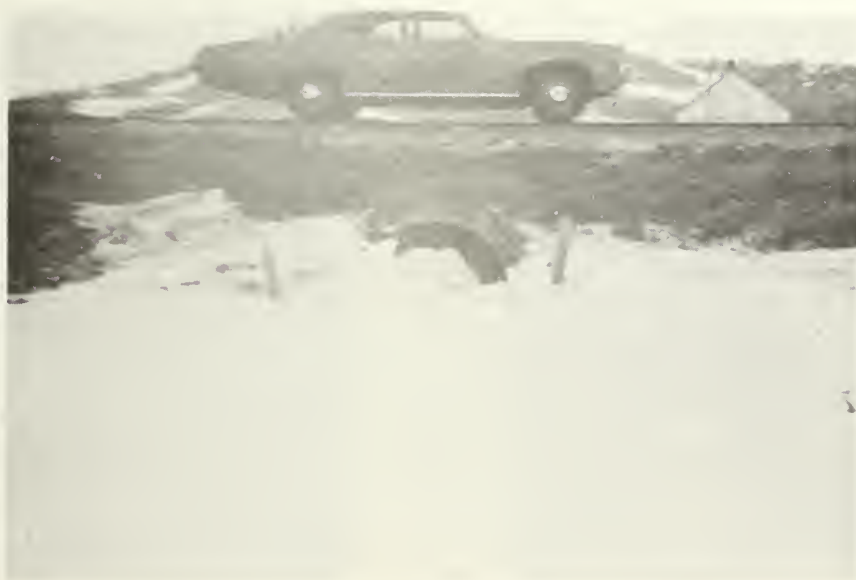
SOUTH ENTRANCE
Snow is crusted from warm temperature
and cold winds.

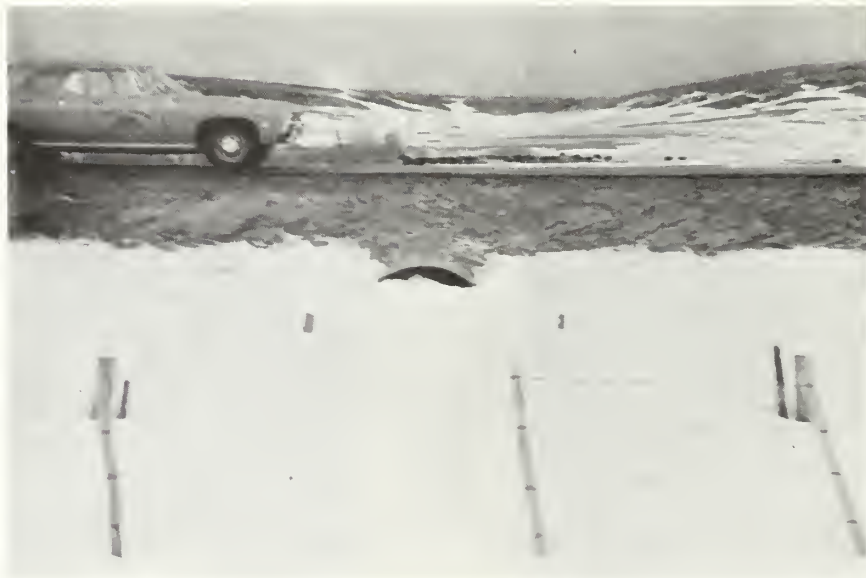
Looking NORTH from SOUTH ENTRANCE
Snow is crusted from warm temp-
eratures and cold winds.

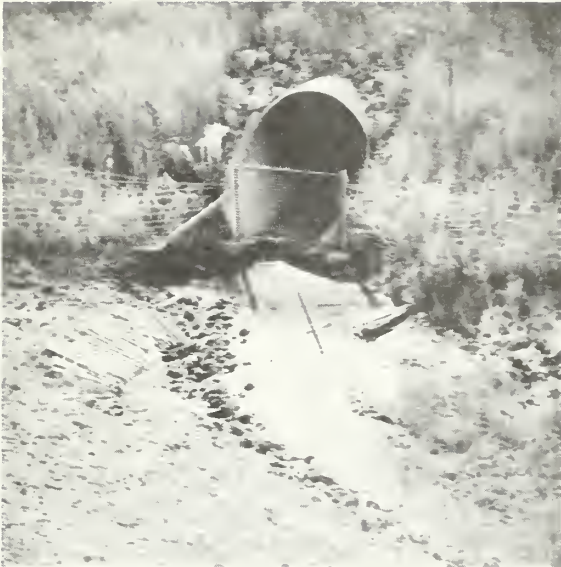
NORTH ENTRANCE
Notice bedspring gate; entrance
is too wet for use at this time

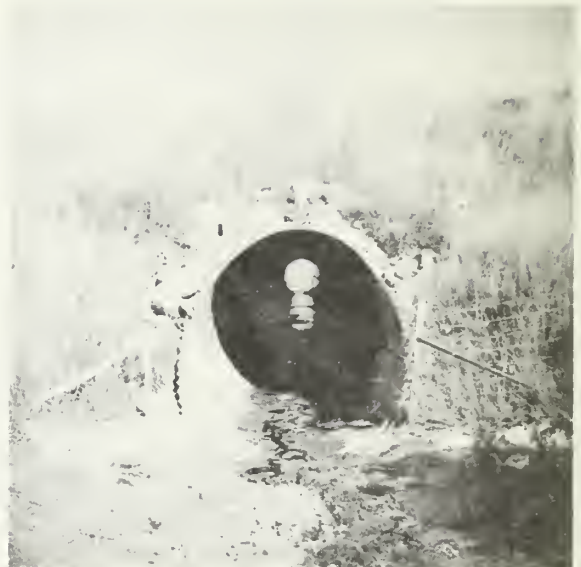
SOUTH ENTRANCE
Notice drainage

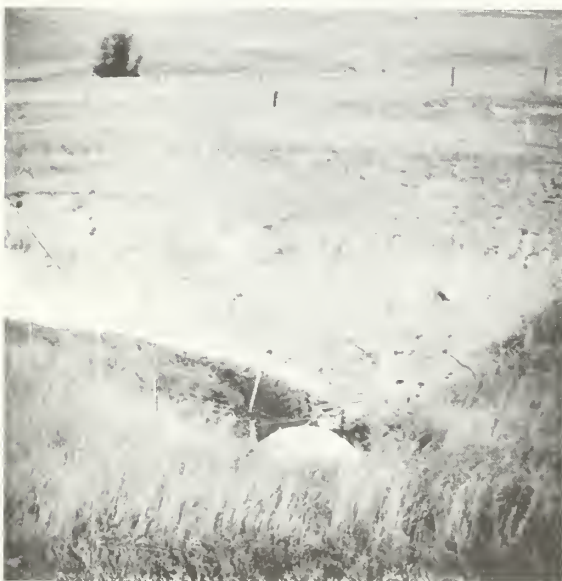
Looking North from NORTH ENTRANCE
Notice trail up bank to dry ground

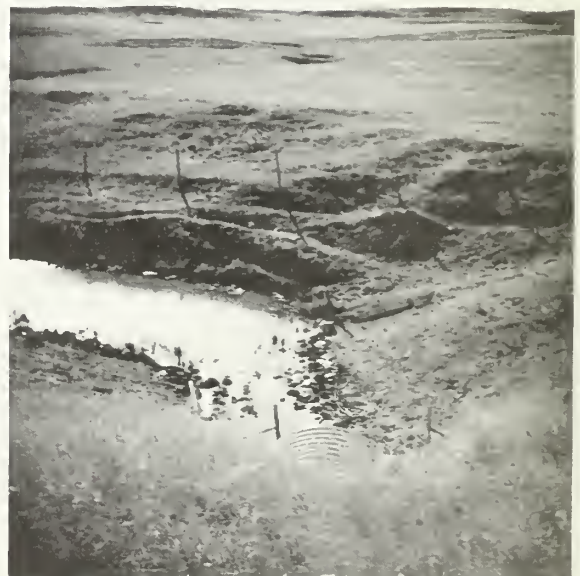
Looking South from SOUTH ENTRANCE
Water is seepage from stock reservoir
above the pipe.

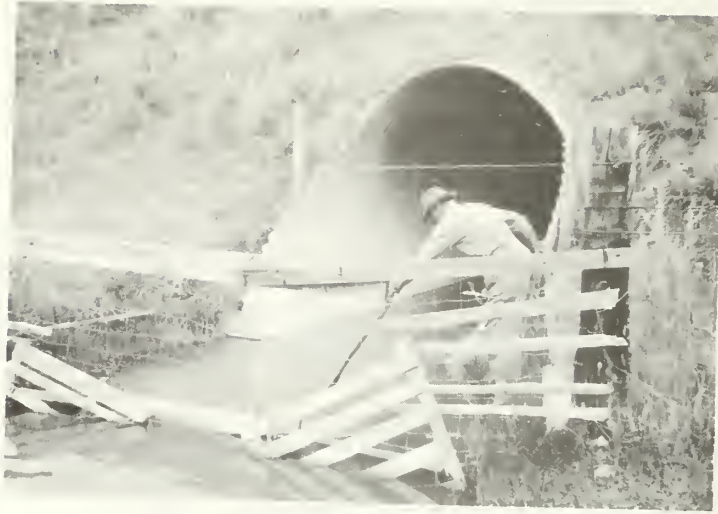
NORTH ENTRANCE
High Water

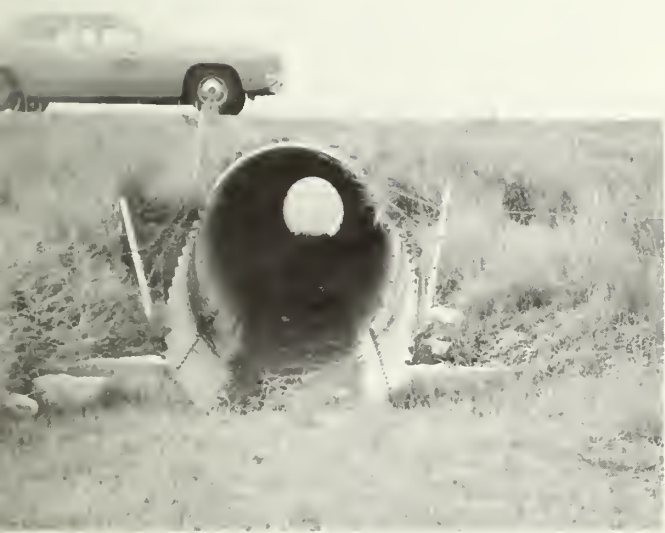
EAST ENTRANCE
Note concrete stabilization

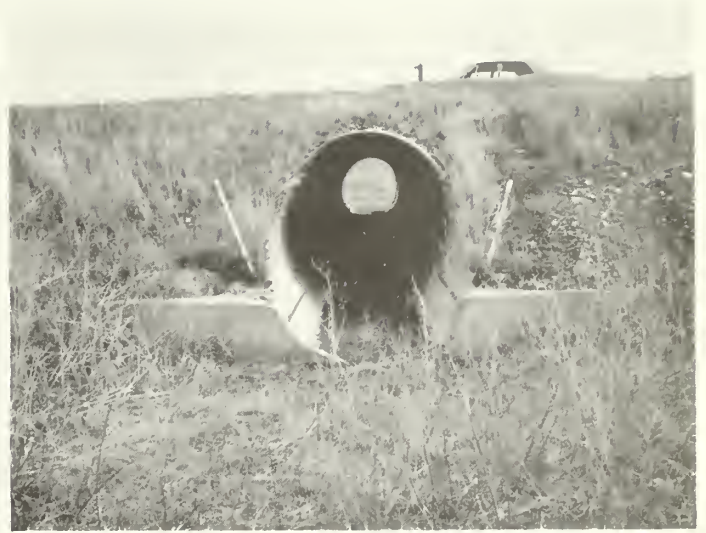
WEST ENTRANCE
Note concrete stabilization

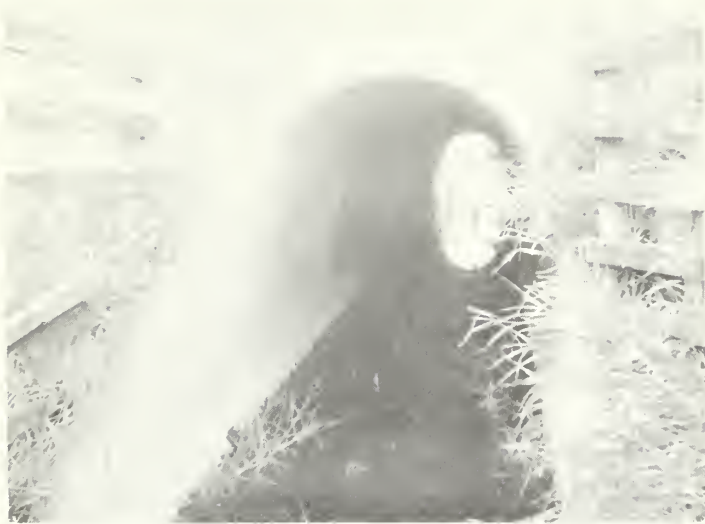
NORTH ENTRANCE
Note water in stockpass

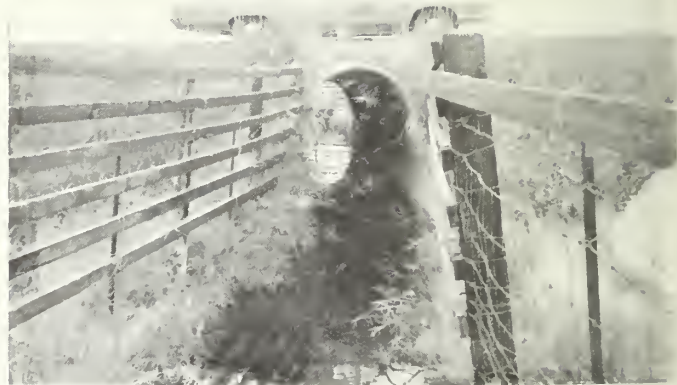
SOUTH ENTRANCE
Note water in stockpass

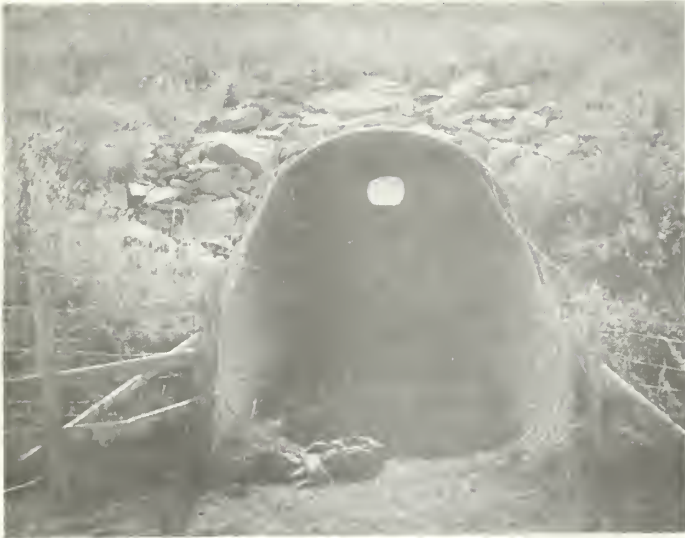
NORTH ENTRANCE; Notice bulge

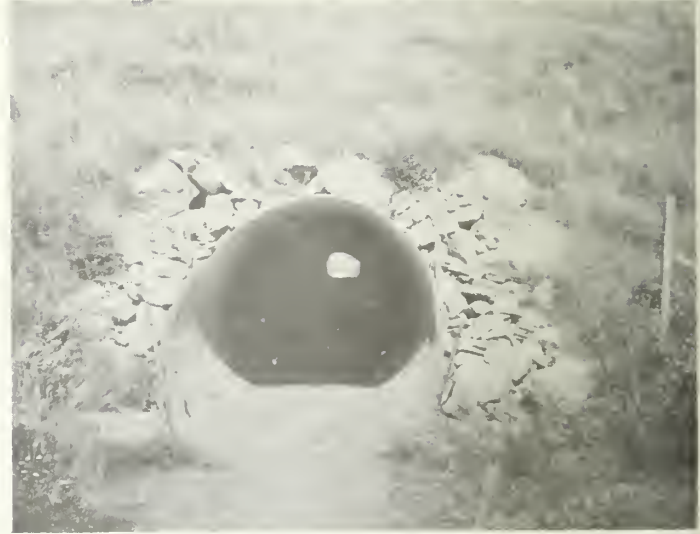
SOUTH ENTRANCE; Notice bulge

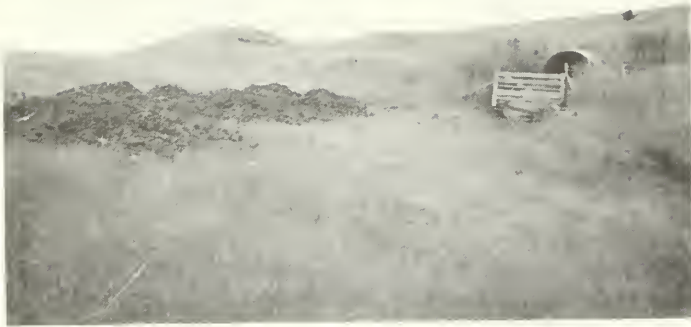
NORTH ENTRANCE, looking towards
Southeast; Notice fill material
cleaned out of pipe

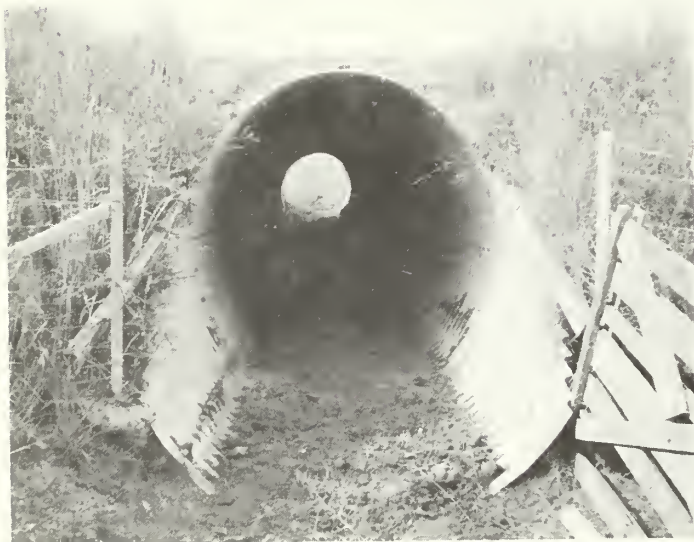
NORTH ENTRANCE: Notice pipe is mis-
shapen

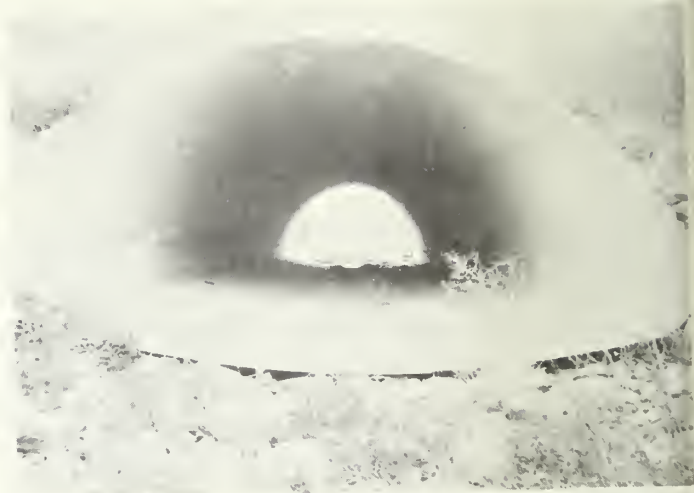
SOUTH ENTRANCE: Notice outlet erosion,
boulders washed in other end

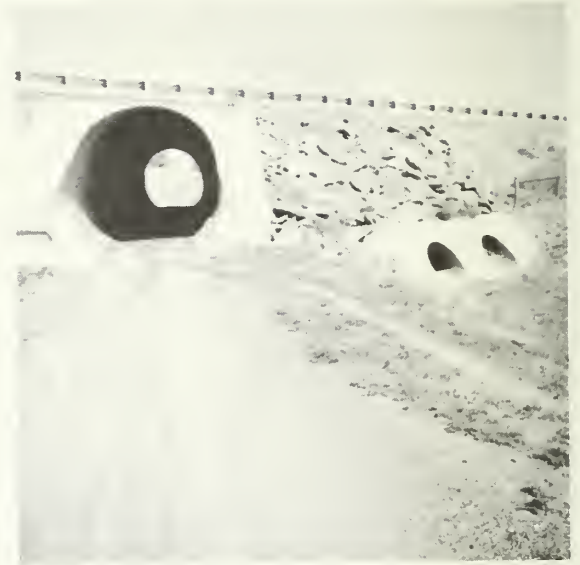
SOUTH ENTRANCE; Notice drainage pipes

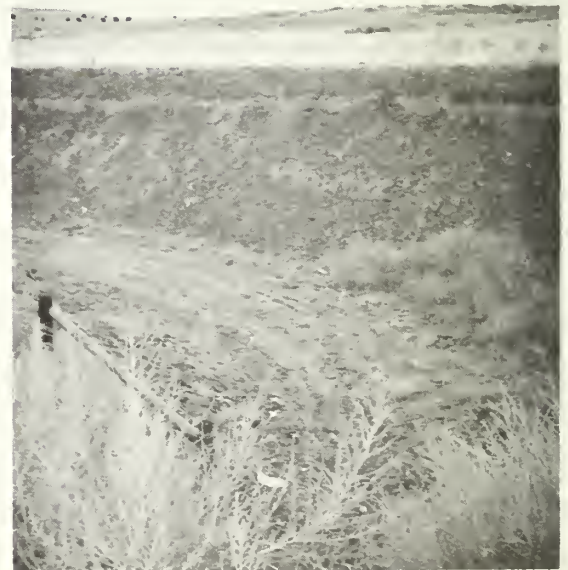
Looking South from SOUTH ENTRANCE
Notice channeling and roadbed

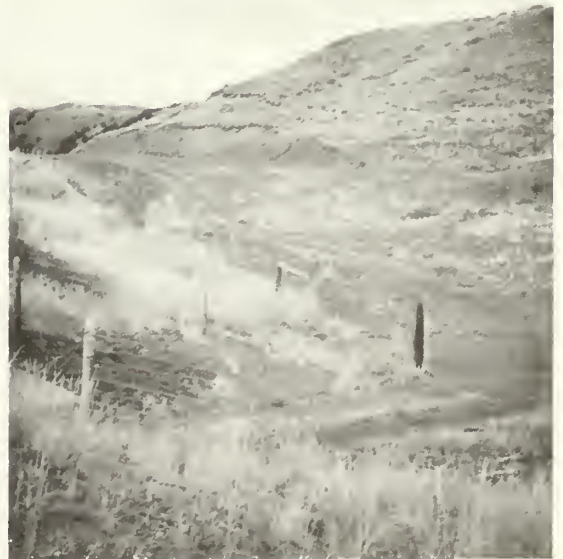
Looking Southeasterly from SOUTH ENT.,
Note approach cut into hillside along
Interstate fence line.

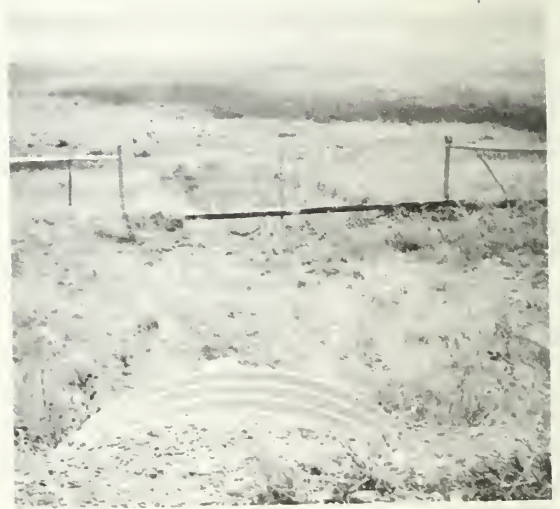
REMARKS: In situations where the highway parallels the railroad tracks, it might be well in some cases to channel stock from the stockpass over the railroad tracks by means of a wing fence and temporary gates across the tracks where permitted. This prevents stock scattering along the railroad right-of-way. It was originally intended as a joint usage structure with the adjoining landowner.

LIVESTOCK AND VEHICULAR UNDERPASSES

South End of Pipe
